Photogrammetry Measurements of Airplane Passenger Entry Doors

by Michael Lazar, The Boeing Company

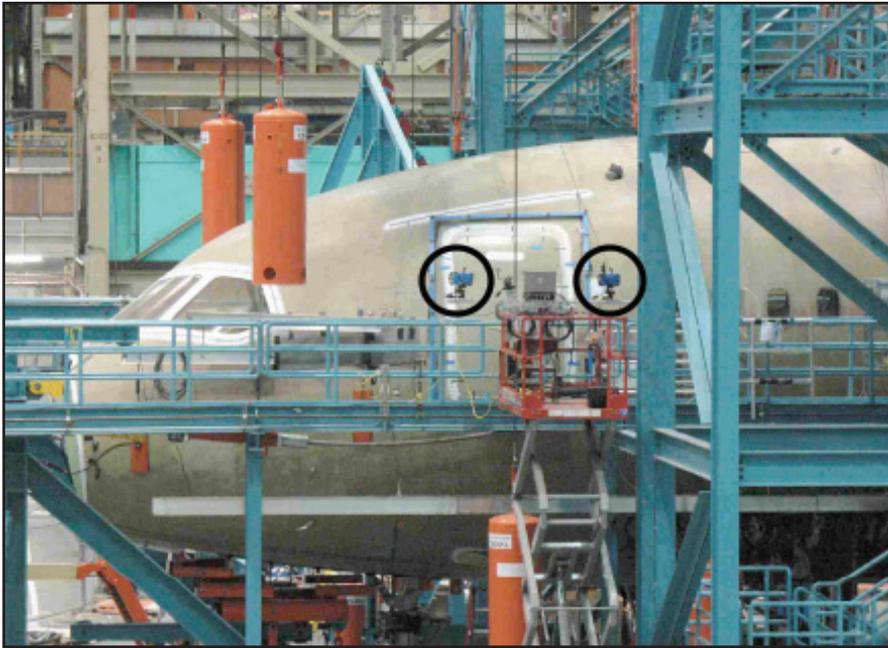
Figure 1. Sequential photogrammetry

To assess the integrity of the entry doors and surrounds, a photogrammetry, multiple camera (M-mode) survey was performed on door number one, left hand, using two Geodetic Services Inc. (GSI) INCA 3 cameras, as seen in figure 1.

During extreme high blow, no personnel are allowed near the airplane, and the entire bay must be cleared as a precaution. Remote-control devices were mounted to the cameras, allowing measurement capture beyond 50 m. A separate, independently valued picture frame was attached to the outer door structure, providing a common point network that also included a scale.

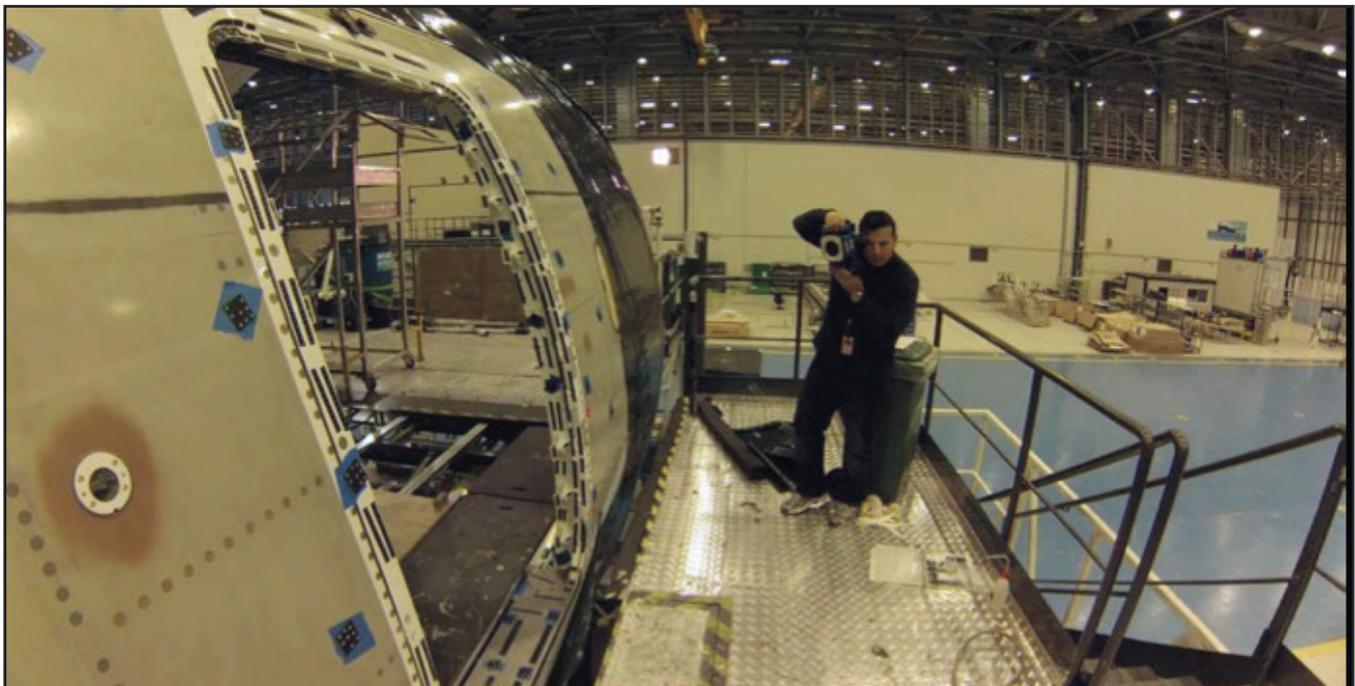
Figure 2. Photogrammetry inspection of a completed door surround

As part of our Boeing 787 inspection procedures, photogrammetry measurements are taken at various stages of the production process on every aircraft to ensure that data are within engineering designed limits. These measurements are taken to identify and remedy leakage problems that could occur during production pressure testing. Inspections are performed at the detail level on all door-surround structures, validating the frames, as seen in figure 2. Hard tooling and floor assembly jigs (FAJs) support the door-surround build. Within the production framework of the door surround, provisions for determinant assembly (DA) pinning exist. The DA holes are used to locate the door-surround structure into the next higher assembly within the fuselage.

To test the effects of assembly and properly track the production hardware throughout the build phase, retroreflective targets are placed at critical locations and aligned through the DA holes. In some cases, data have been collected at one supplier, shipped to a different location for additional assembly, and then measured in final assembly for acceptance at Boeing facilities in Everett, Washington, or North Charleston, South Carolina, prior to delivery. Through the use of the photogrammetry targets, direct comparisons can easily be made in a point-to-point fashion and without retargeting prior to each inspection.

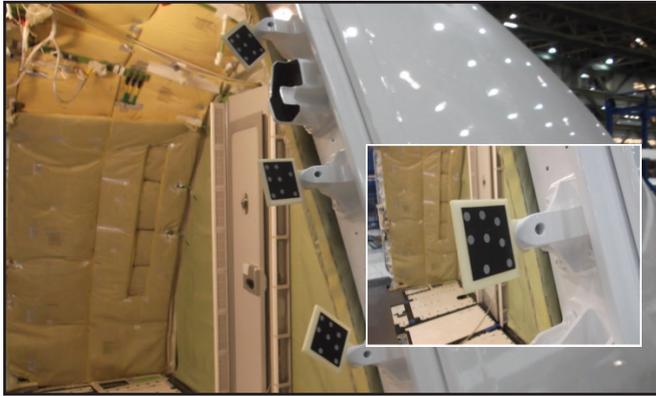
Figure 3. Rapid prototyped feature targets installed on the door-surround datums

rapid-prototyped parts were fabricated to create an easy way of measuring the center point, as seen in figure 3. Feature targets, magnetically attached to the door-stop button locations, are self-recognized through the photogrammetry software, automatically extracting the true center point.

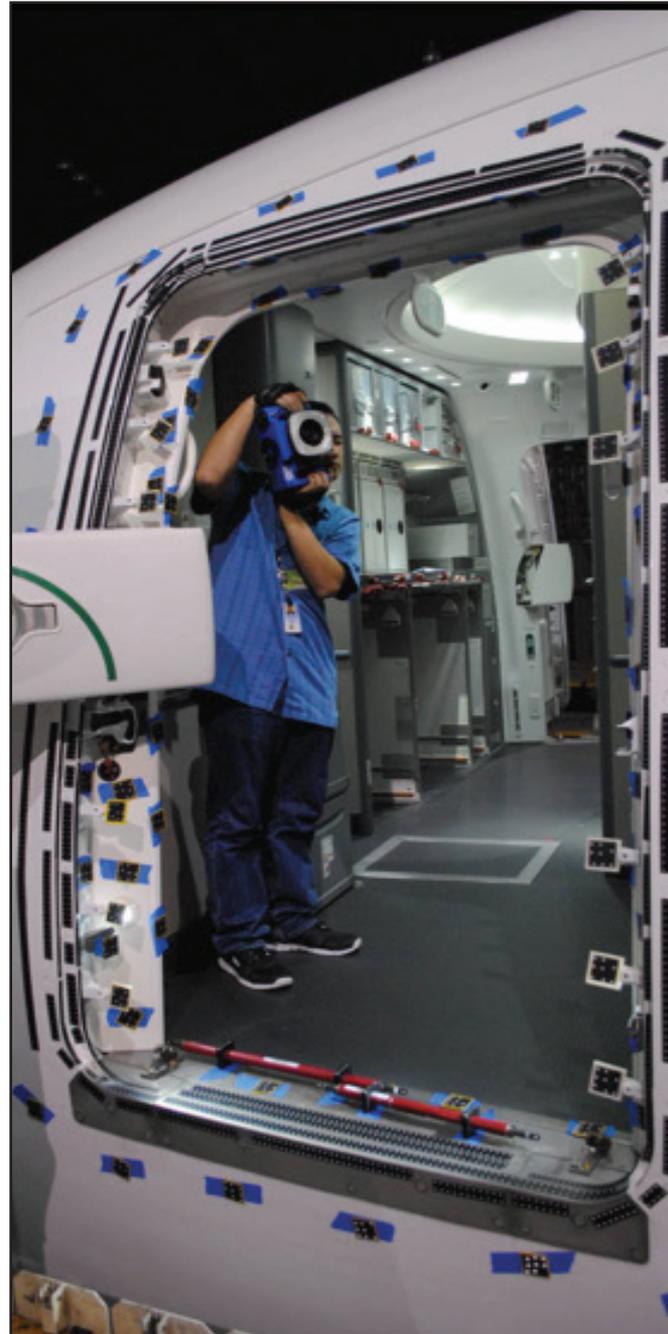
Figure 4. Top view of the network geometry, and photography from the support platform

Unfortunately, some pressure leaks may develop after delivery and require in-service repair. Through the portability of the GSI photogrammetry system, the equipment can be brought onto the airplane as checked luggage and travel to any destination. For example, a repair was necessary to remedy a door seal discrepancy on door one, left hand, on one airplane in service. To deduce the nature of the error, a photogrammetry survey was performed at 0 psi and again at pressure, as seen in

figure 4. To minimize the effect in terms of revenue-generating flights, the inspection was performed during an originally scheduled downtime. Routine maintenance was taking place while a concurrent photogrammetry inspection session was performed.

Because multiple inspections were required, both at zero pressure and with pressure, a common reference system network was necessary to link the two surveys. With the primary datum structure located within the interior of the door-surround frame, on the stop buttons, and the inspection area of interest on the exterior door and corresponding fuselage, a total of three independent surveys was necessary. An initial survey performed the actual alignment and inspection of the interior features while assigning transformation values to the exterior targets. With the door closed, a second survey was performed at zero pressure, transforming back into the datum structure through the common point network, as seen in figure 5. The final survey performed at pressure utilized the same exterior target transformation points. Outcome between the

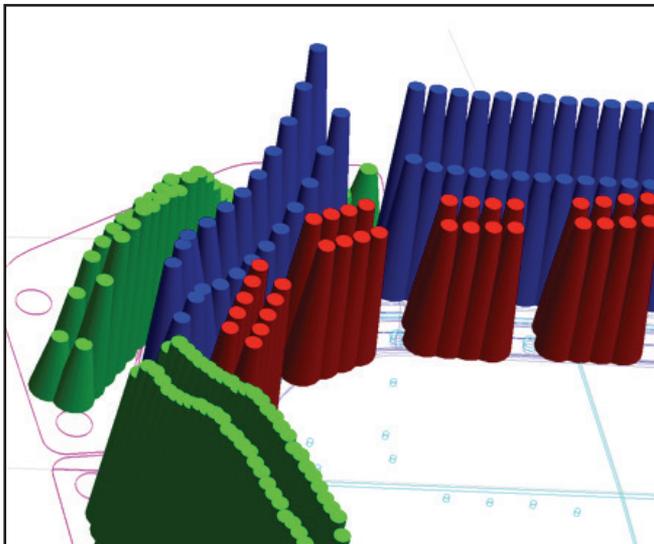
Figure 6. Upper seal surface example

zero and at-pressure tests revealed a stepped condition of the door's edge protection with respect to the upper seal edge, as seen in figure 6. The step or under-shimmed condition resulted in a high-speed airflow disturbance that was noticeable to the customer at cruise altitude and speed. A shim was installed under the edge protector at the upper-forward corner to remedy the discrepant condition.
